# PRESS INFO

## JOSKIN POLSKA Galvanising Plant: the Event of the Decade

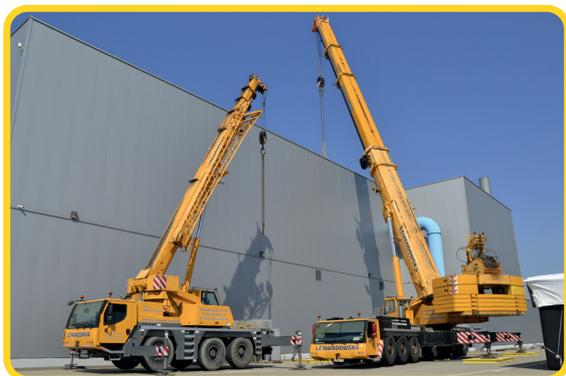
*Cranes in action to replace the tank*

This project was not that easy as it required meticulous planning and top-quality workmanship to achieve the desired result. The preparations included: ordering and transporting the tank, pumping the zinc, building a rail track in the factory, preparing the technicians, preparing the fume extraction box... and even: partially dismantling the factory roof! The crane indeed did not allow to lift the tank out of the furnace to then take it out through the removable wall... What to do in this case? Dismantle the roof to allow the different cranes to do all the work! Really nothing stops JOSKIN...

After 5 days of preparatory work (from 10/08/2020 to 15/08/2020), the new 47-ton empty bath was finally introduced into the building. After that, the tank has been heated up for 48 hours, the liquid zinc has been pumped into the new bath and then it has been filled up gradually by adding zinc ingots.
